ROAD HAZARDS: EXPLORING THE ROLE OF TIRES WHEN AN ACCIDENT OCCURS

Benjamin Iverson, Ph.D. S-E-A

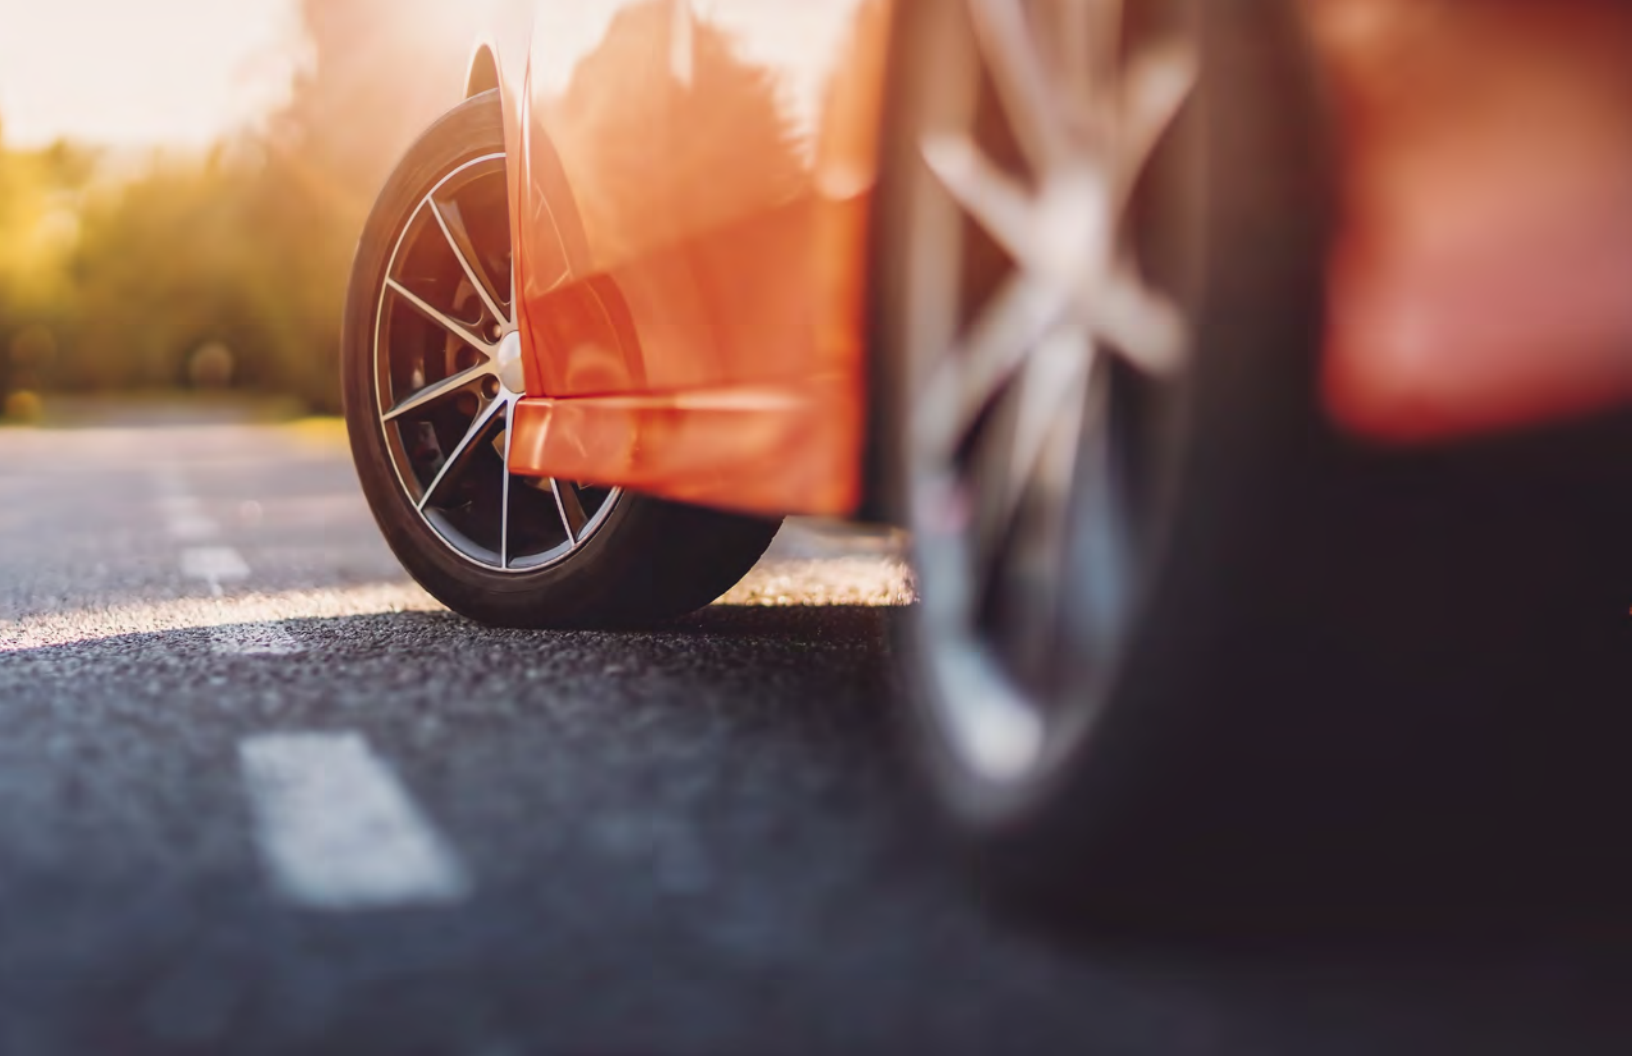
The presence of a puncturing object in the tire is not by itself enough to determine the cause of failure. As many tires continue to move, even after a loss of pressure has occurred (typically summarized as a run-flat condition), the possibility for the tire to pick up road debris after it has been compromised cannot be discounted. A breach that occurs after the tire has lost air pressure will have characteristics that are different from a breach that occurs while the tire is still under pressure.

To illustrate this point, think of a common fear when driving: the tire runs over a nail. In the simplest case, the nail penetrates through the tread, through whatever internal components are present in the construction (belts, plies, overlays, etc.), and through the inner liner of the tire. The inner liner of the tire is designed to keep the tire inflated, and the introduction of a breach now means a direct path for the internal pressure to reach the environment has occurred. This can cause an immediate development of a flat tire. From an examination perspective, the observation of a puncturing object, which can be tied directly to the loss of pressure in the tire and, therefore, a loss of performance, means there was nothing inherently wrong with the design, manufacturing, maintenance, or operation of the tire.
